# **EMAX II** 16 – BIT DIGITAL SOUND SYSTEM

# STEREO SAMPLING RETROFIT INSTRUCTIONS

## STEREO SAMPLING Retrofit Instructions

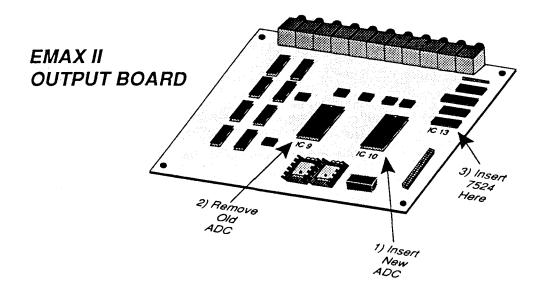
- 1) Insert the new 5326 Stereo ADC into the empty socket at IC 10. Next, remove the old 5126 ADC from the socket in the output board at location IC 9.
- 2) Insert the 7524 Volume DAC into the empty socket at location IC 13 on the output board.

Refer to the diagrams and perform the following IC replacements:

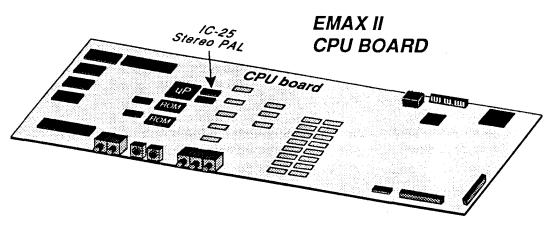
3) Remove the IC at location IC 25 on the CPU board and replace it with the GSTEREO PAL (supplied).
